HOME REPORT

DUNBEATH
26 COUNCILLORS WALK
FORRES
IV36 1HA

Energy Performance Certificate (EPC)

Single Survey

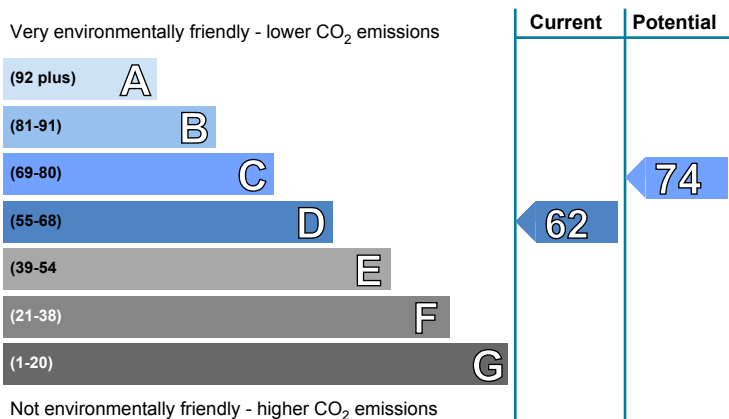
Environmental Impact (CO₂) Rating

This graph shows the effect of your home on the environment in terms of carbon dioxide (CO₂) emissions. The higher the rating, the less impact it has on the environment.

Your current rating is **band D (62)**. The average rating for EPCs in Scotland is **band D (59)**.

The potential rating shows the effect of undertaking all of the improvement measures listed within your recommendations report.
