HOME REPORT

77 KING STREET
BURGHEAD
ELGIN
IV30 5XG

ENERGY PERFORMANCE CERTIFICATE

77 KING STREET, BURGHEAD, ELGIN, IV30 5XG

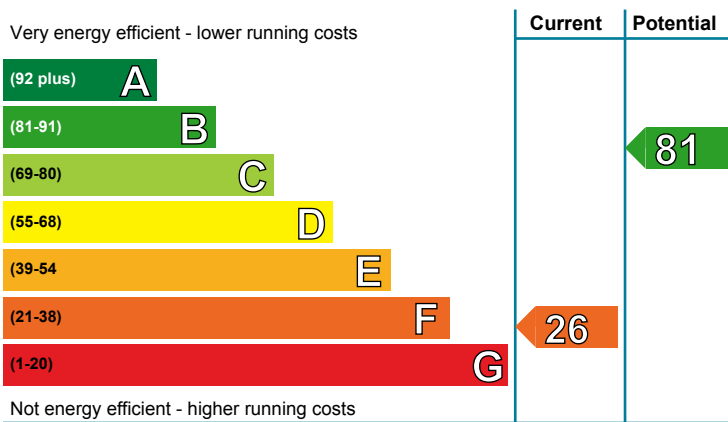
Energy Efficiency Rating

This graph shows the current efficiency of your home, taking into account both energy efficiency and fuel costs. The higher this rating, the lower your fuel bills are likely to be.

Your current rating is **band F (26)**. The average rating for EPCs in Scotland is **band D (61)**.

The potential rating shows the effect of undertaking all of the improvement measures listed within your recommendations report.

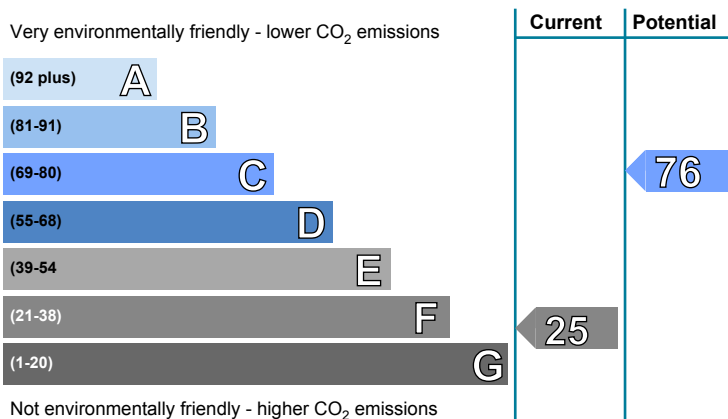
Environmental Impact (CO₂) Rating

This graph shows the effect of your home on the environment in terms of carbon dioxide (CO₂) emissions. The higher the rating, the less impact it has on the environment.

Your current rating is **band F (25)**. The average rating for EPCs in Scotland is **band D (59)**.

The potential rating shows the effect of undertaking all of the improvement measures listed within your recommendations report.

The average Scottish household produces about 6 tonnes of carbon dioxide every year. Based on this assessment, heating and lighting this home currently produces approximately 9.6 tonnes of carbon dioxide every year. Adopting recommendations in this report can reduce emissions and protect the environment. If you were to install all of these recommendations this could reduce emissions by 7.0 tonnes per year. You could reduce emissions even more by switching to renewable energy sources.
