HOME REPORT

Kilravock
45 Findhorn
Forres
IV36 3YF

Energy Performance Certificate (EPC)

Single Survey

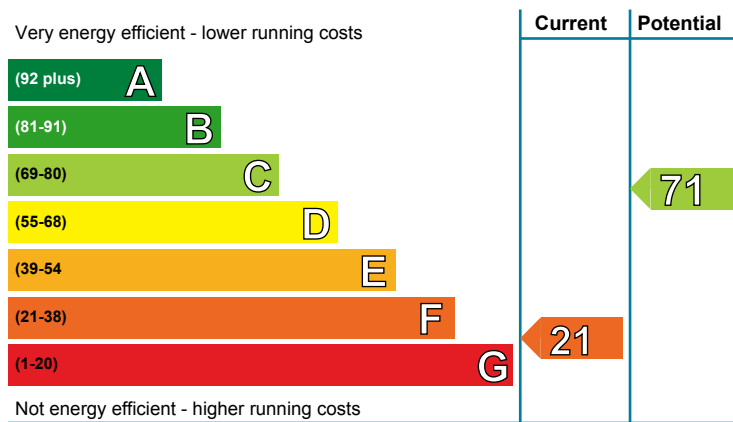
Energy Efficiency Rating

This graph shows the current efficiency of your home, taking into account both energy efficiency and fuel costs. The higher this rating, the lower your fuel bills are likely to be.

Your current rating is **band F (21)**. The average rating for EPCs in Scotland is **band D (61)**.

The potential rating shows the effect of undertaking all of the improvement measures listed within your recommendations report.

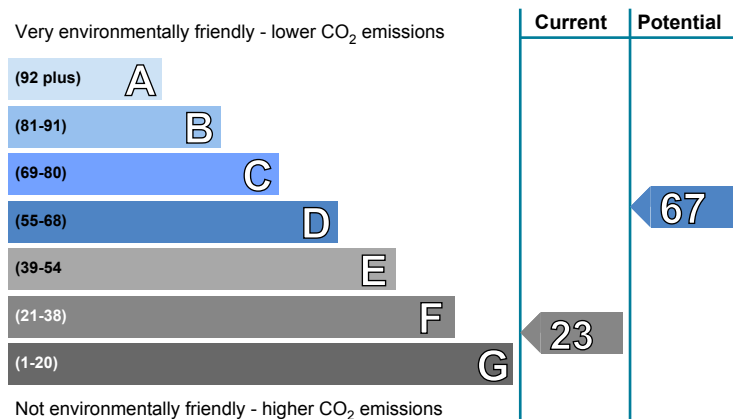
Environmental Impact (CO₂) Rating

This graph shows the effect of your home on the environment in terms of carbon dioxide (CO₂) emissions. The higher the rating, the less impact it has on the environment.

Your current rating is **band F (23)**. The average rating for EPCs in Scotland is **band D (59)**.

The potential rating shows the effect of undertaking all of the improvement measures listed within your recommendations report.
