HOME REPORT

SANDBANK FINDHORN

FORRES
IV36 3YY

Single Survey

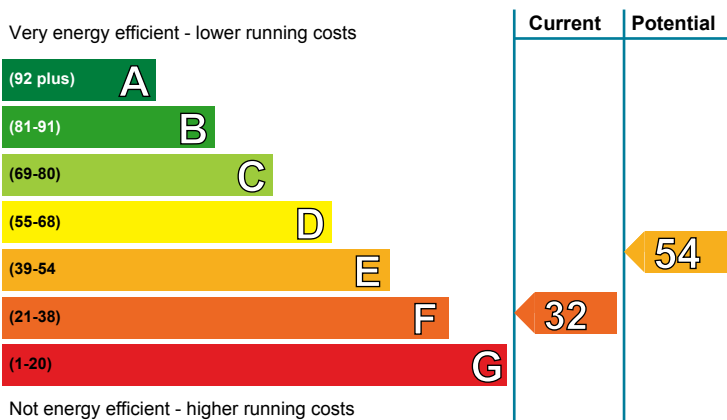
Energy Efficiency Rating

This graph shows the current efficiency of your home, taking into account both energy efficiency and fuel costs. The higher this rating, the lower your fuel bills are likely to be.

Your current rating is **band F (32)**. The average rating for EPCs in Scotland is **band D (61)**.

The potential rating shows the effect of undertaking all of the improvement measures listed within your recommendations report.
