HOME REPORT

THE OLD MANSE DYKE

FORRES
IV36 2TF

Energy Performance Certificate (EPC)

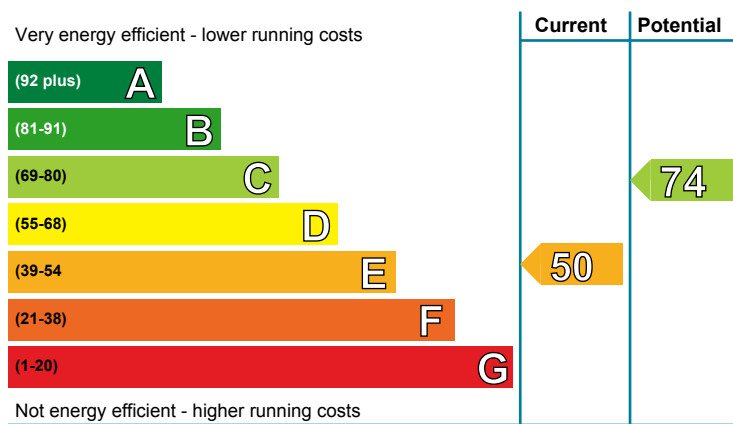
Energy Efficiency Rating

This graph shows the current efficiency of your home, taking into account both energy efficiency and fuel costs. The higher this rating, the lower your fuel bills are likely to be.

Your current rating is **band E (50)**. The average rating for EPCs in Scotland is **band D (61)**.

The potential rating shows the effect of undertaking all of the improvement measures listed within your recommendations report.

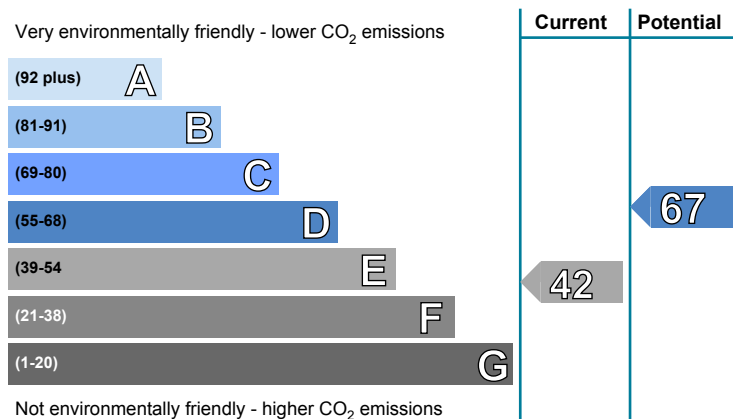
Environmental Impact (CO₂) Rating

This graph shows the effect of your home on the environment in terms of carbon dioxide (CO₂) emissions. The higher the rating, the less impact it has on the environment.

Your current rating is **band E (42)**. The average rating for EPCs in Scotland is **band D (59)**.

The potential rating shows the effect of undertaking all of the improvement measures listed within your recommendations report.
