HOME REPORT

15 WILSON STREET
NAIRN
IV12 4NY

Energy Performance Certificate (EPC)

15 WILSON STREET, NAIRN, IV12 4NY

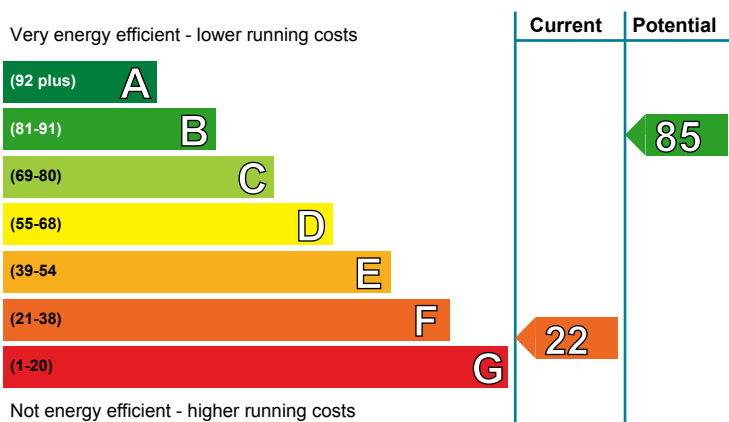
Energy Efficiency Rating

This graph shows the current efficiency of your home, taking into account both energy efficiency and fuel costs. The higher this rating, the lower your fuel bills are likely to be.

Your current rating is **band F (22)**. The average rating for EPCs in Scotland is **band D (61)**.

The potential rating shows the effect of undertaking all of the improvement measures listed within your recommendations report.

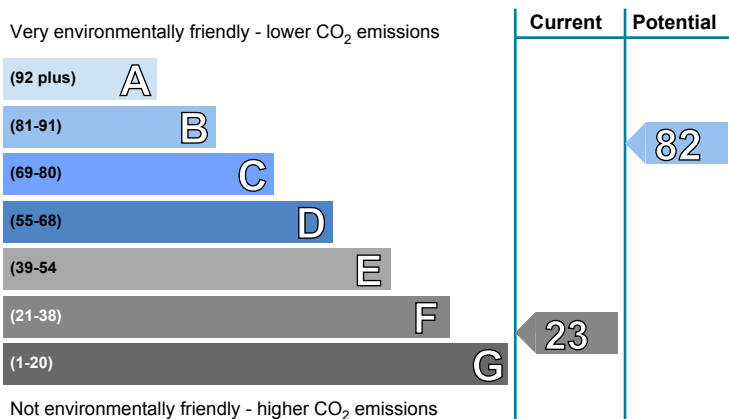
Environmental Impact (CO₂) Rating

This graph shows the effect of your home on the environment in terms of carbon dioxide (CO₂) emissions. The higher the rating, the less impact it has on the environment.

Your current rating is **band F (23)**. The average rating for EPCs in Scotland is **band D (59)**.

The potential rating shows the effect of undertaking all of the improvement measures listed within your recommendations report.
