# HOME REPORT

44 PARK STREET  
NAIRN  
IV12 4PP

# Energy Performance Certificate (EPC)

44 PARK STREET, NAIRN, IV12 4PP

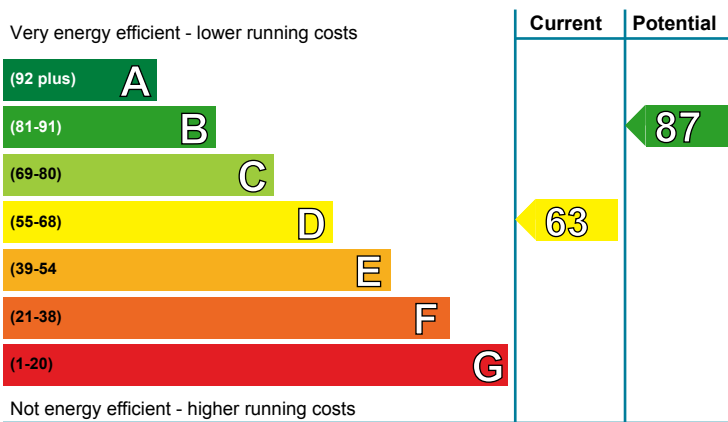
## Energy Efficiency Rating

This graph shows the current efficiency of your home, taking into account both energy efficiency and fuel costs. The higher this rating, the lower your fuel bills are likely to be.

Your current rating is **band D (63)**. The average rating for EPCs in Scotland is **band D (61)**.

The potential rating shows the effect of undertaking all of the improvement measures listed within your recommendations report.

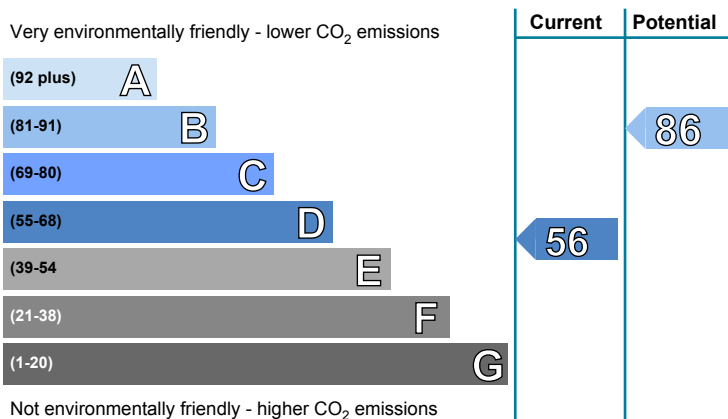
## Environmental Impact (CO<sub>2</sub>) Rating

This graph shows the effect of your home on the environment in terms of carbon dioxide (CO<sub>2</sub>) emissions. The higher the rating, the less impact it has on the environment.

Your current rating is **band D (56)**. The average rating for EPCs in Scotland is **band D (59)**.

The potential rating shows the effect of undertaking all of the improvement measures listed within your recommendations report.

The average Scottish household produces about 6 tonnes of carbon dioxide every year. Based on this assessment, heating and lighting this home currently produces approximately 6.0 tonnes of carbon dioxide every year. Adopting recommendations in this report can reduce emissions and protect the environment. If you were to install all of these recommendations this could reduce emissions by 3.7 tonnes per year. You could reduce emissions even more by switching to renewable energy sources.
