Home Report

Scottish Single Survey

Property address	8 Ness Street Nairn IV12 5SL
Customer	Mrs Elaine McCluskey
Customer address	8 Ness Street Nairn IV12 5SL
Prepared by	Shepherd Chartered Surveyors
Date of inspection	27/06/2024

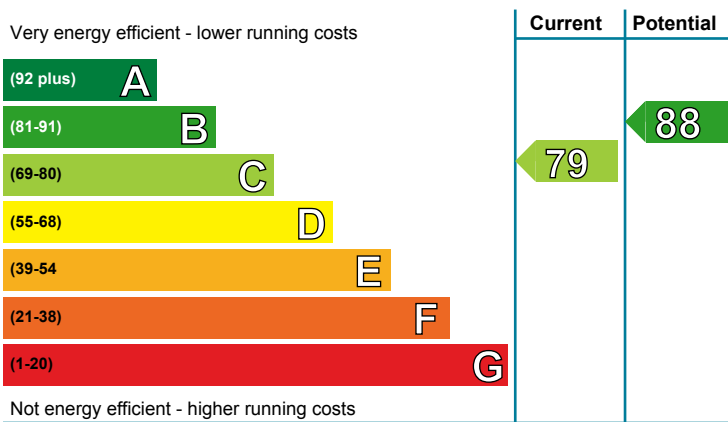
Energy Efficiency Rating

This graph shows the current efficiency of your home, taking into account both energy efficiency and fuel costs. The higher this rating, the lower your fuel bills are likely to be.

Your current rating is **band C (79)**. The average rating for EPCs in Scotland is **band D (61)**.

The potential rating shows the effect of undertaking all of the improvement measures listed within your recommendations report.

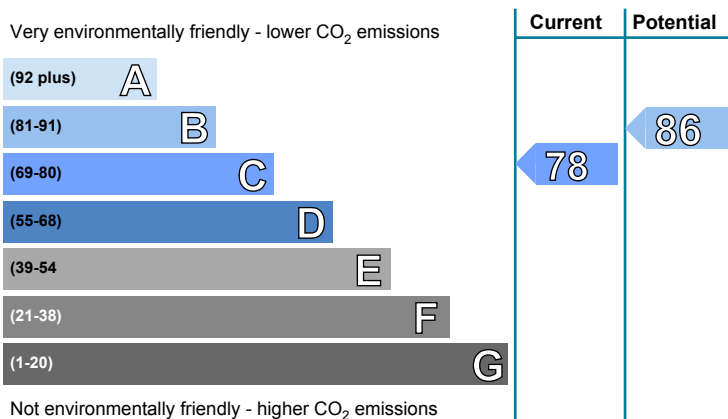
Environmental Impact (CO₂) Rating

This graph shows the effect of your home on the environment in terms of carbon dioxide (CO₂) emissions. The higher the rating, the less impact it has on the environment.
