HOME REPORT

VORLICH
9 WELLINGTON ROAD
NAIRN
IV12 4RE

Energy Performance Certificate (EPC)

VORLICH, 9 WELLINGTON ROAD, NAIRN, IV12 4RE

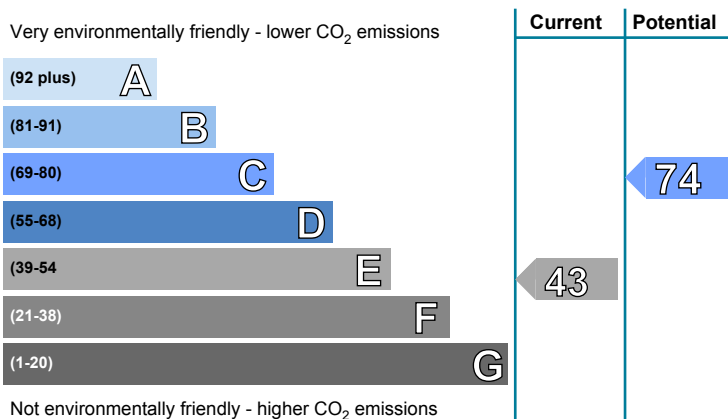
Environmental Impact (CO₂) Rating

This graph shows the effect of your home on the environment in terms of carbon dioxide (CO₂) emissions. The higher the rating, the less impact it has on the environment.

Your current rating is **band E (43)**. The average rating for EPCs in Scotland is **band D (59)**.

The potential rating shows the effect of undertaking all of the improvement measures listed within your recommendations report.

The average Scottish household produces about 6 tonnes of carbon dioxide every year. Based on this assessment, heating and lighting this home currently produces approximately 11 tonnes of carbon dioxide every year. Adopting recommendations in this report can reduce emissions and protect the environment. If you were to install all of these recommendations this could reduce emissions by 5.9 tonnes per year. You could reduce emissions even more by switching to renewable energy sources.
